**Flood Control Project Maintenance
Levee Inspections**

Fall 2018 Levee Maintenance Deficiency Summary Report

Sacramento River Basin

Reclamation District No. 0537 Lovdal

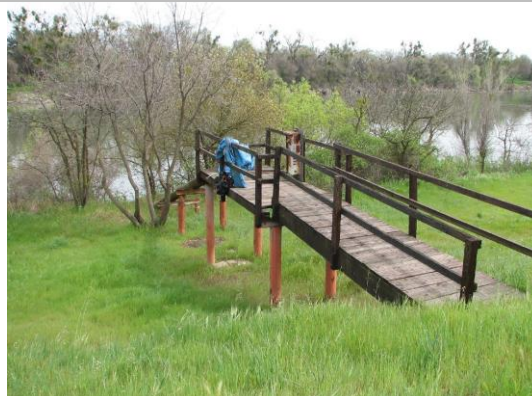
Photo 1 of 3 : UCIP_FA_2018_46041_17171.jpg

LM Start	3.06	Rating **	M	Issue No.	270	
LM End	3.06	Issue Type +	En	Location *		
Category	Supplemental			GPS Latitude/Longitude		
				Start		End
Item	DWR UCIP Field Study			38.616413 °		38.616413 °
				-121.563205 °		-121.563205 °
DWR ID	181					
Comment Code						
Inspector Comment						
FS_ID:46041 DS_ID:181 EP_NO: N/A Repair Type: Non-Urgent Crossing Status: Found UCIP Comments: Obstructed siphon breaker. FIELD_STRUCT_DESC: 12-inch steel irrigation discharge pipe through the levee, 7 feet below the crown. Slant pump column on the riverbank. Timber walkway mounted on a pile structure across the berm to the pump. Siphon breaker in a corrugated metal pipe (CMP) riser on the landside (LS) slope. Concrete standpipe on the LS. 6-inch waste line down the waterside (WS) bank with a gate valve. [Additional Reference(s): DWR Levee Log, 2004]. FS Date: 3/18/2013

WS- overview of slanted pipe and pump on steel pile structure

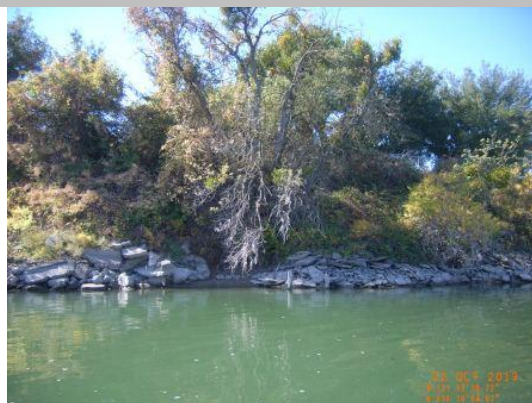
Photo 1 of 1 : FA_2018_RD0537_173_19_20181106_00023.jpg

LM Start	4.14	Rating **	A/W	Issue No.	19
LM End	4.24	Issue Type +	Ma	Location *	WS
Category	Supplemental			GPS Latitude/Longitude	
				Start	End
Item	2017 USACE Erosion Survey, DRAFT			38.602874 °	38.601718 °
				-121.554620 °	-121.553629 °
DWR ID	DWR_RD0537_01_f_2018_19				
Comment Code					
Inspector Comment					
2017 Site ID: SAC 62.9 R Status: Eroding 2017 Field Notes: Fresh erosion pocket near downstream end. Site History: 1997 - This may have been a cobble rehabilitation site to the 1957 cobble that was place all the way to the I-80 Bridge. 2000 - Local damage induced by human use. 2003 - Site is still very close to the levee and into the levee toe. 2011 - One new tree has fallen. 2015 - Sites 62.9 and 63 were combined into one site. 2018: DWR Inspector: Super wide section of levee, erosion does not appear to be within theoretical prism.
